## Assessing the Health of Toronto Street Trees Irrigated by Stormwater

This study, conducted in partnership with the City of Toronto, assesses the health of street trees planted in 'soil cells' and conventional tree trenches. Three sets of the same two tree species (Freeman Maple and American Elm) planted in 2009 on Queensway Boulevard in Toronto were compared. The first two sets of trees were planted in supported soil cell systems (silva cell™). The others planted further west in tree trenches according to standard City of Toronto tree planting specifications were used as controls. One set of soil cell trees has been receiving stormwater runoff since the trees were planted. The other adjacent set of trees had the stormwater inlet pipe intentionally plugged by Toronto staff after 2 years to facilitate assessment of the effects of stormwater runoff on tree health. The standard control trees were not irrigated with stormwater runoff.

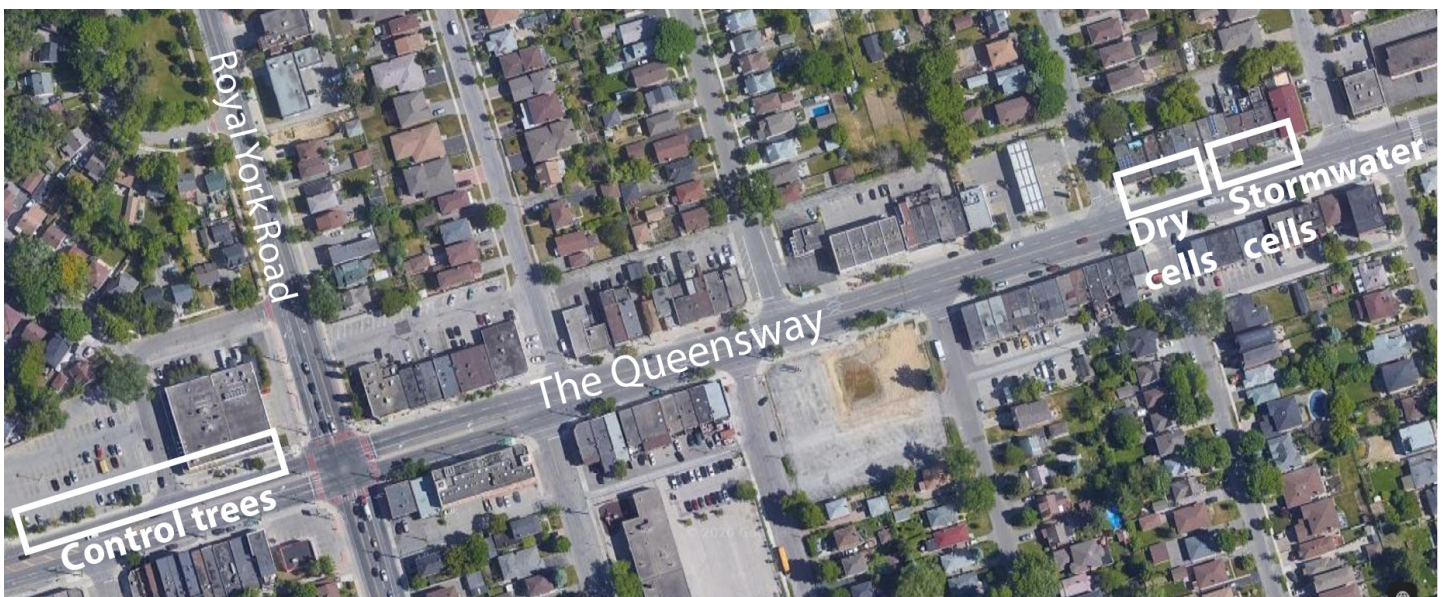
**Figure 1.** Location of Soil Cells (dry and stormwater) and Control Trees on Queensway Blvd in Toronto

The site of the study was on Queensway Boulevard, a 4 lane arterial road in Toronto (Figure 1). Three sites with at least one American Elm (*ulmus americana*) and Freeman Maple (cross between *acer saccharinum* and *acer rubrum*) planted in the same year (2009) were selected for evaluation. These sites included (i) trees in soil cells (silva cells™) with stormwater drainage (referred to as stormwater cells), (ii) trees in soil cells with stormwater drainage during the first 2 year establishment phase (referred to as dry cells), and (iii) eight trees (5 Elm and 3 Maple) planted in a standard trench configuration according to Toronto guidelines (referred to as the control). The stormwater and dry cells were adjacent to one another on the north side of Queensway Blvd. The control trees were further west on the same street adjacent to a retail parking lot. Sodium chloride road salts are used

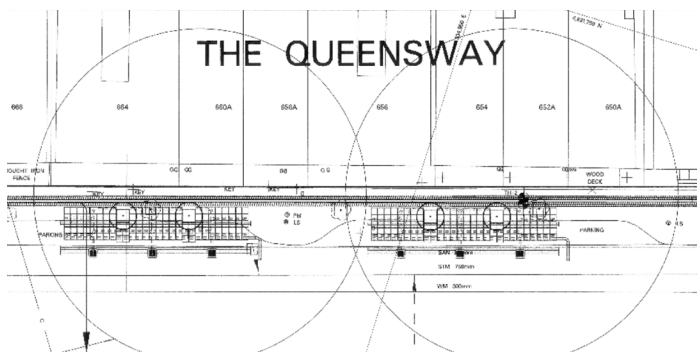
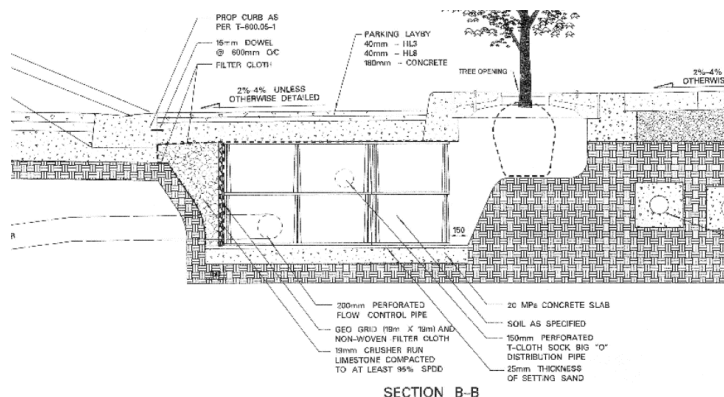
Figure 2. Schematic showing soil cells in plan view (left) and cross section (right).

The design of the soil cells is presented in Figure 2. Stormwater runoff drains from the road into a streetside catchbasin where it is directed into the soil cell via a perforated 100 mm diameter distribution pipe. Water from the distribution pipe is filtered by the proprietary sandy soil mixture in the cells and drained by perforated pipes at the base to a storm sewer. Note that the inlet distribution pipe is located away from the root ball to protect roots from salt and other contaminants during the establishment phase.

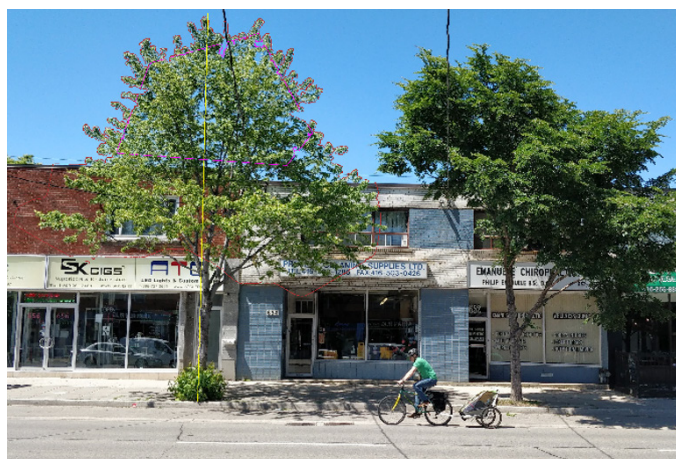
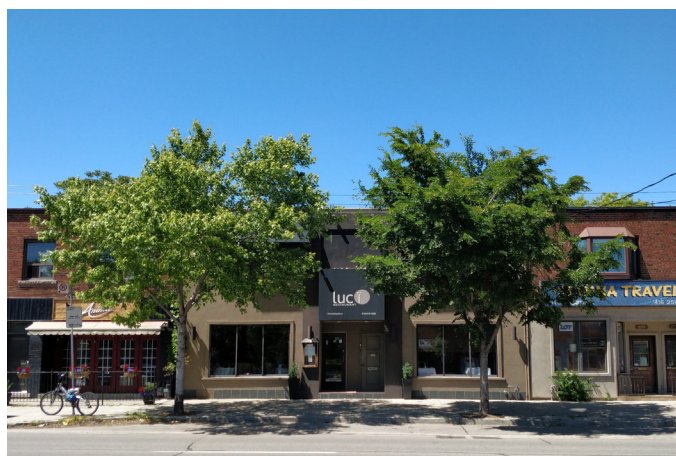
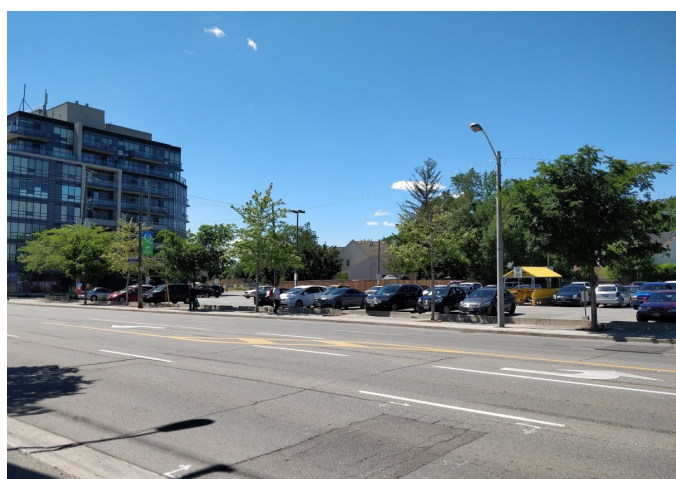
Figure 3. Stormwater trees (top) and dry cell trees (middle) and control trees (bottom) in June 2018

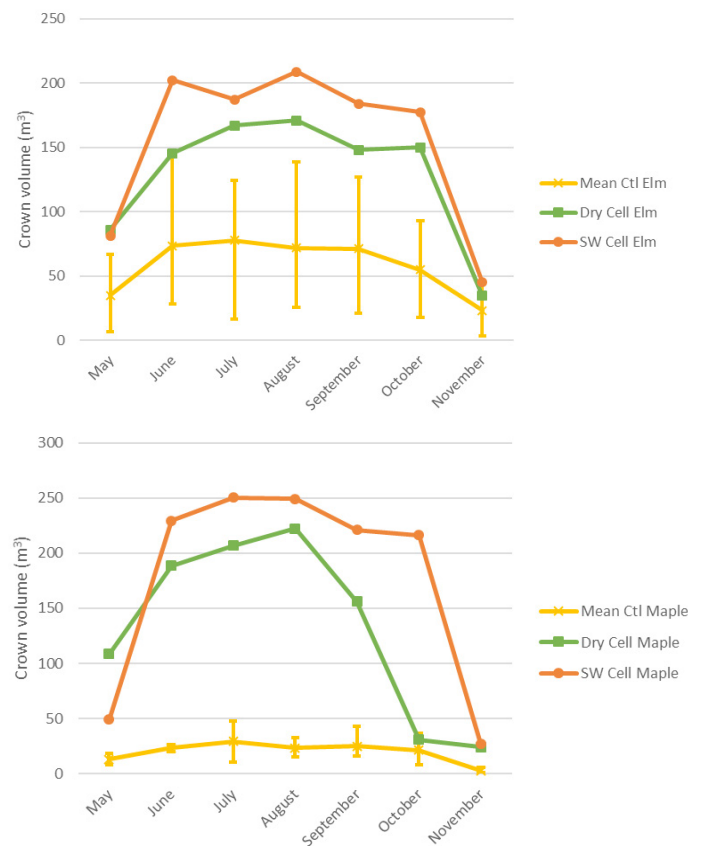
**Figure 6.** The crown volumes of the stormwater cells, dry cells and control trees. Elm (top) and Maple (bottom). Error bars for the control trees represent the minimum and maximum observed values.

**Similar results were shown for crown volumes, with the stormwater cell trees registering the largest volume, followed by the dry cell trees and then the control trees (Figure 6 and 7).** The control trees had much smaller crown volumes than the trees in soil cells. City of Toronto Parks and Forestry staff suggested that lower levels of manual irrigation of the control trees during the establishment phase may have contributed to this result. Unfortunately, data were not available to confirm and quantify the influence of this factor.

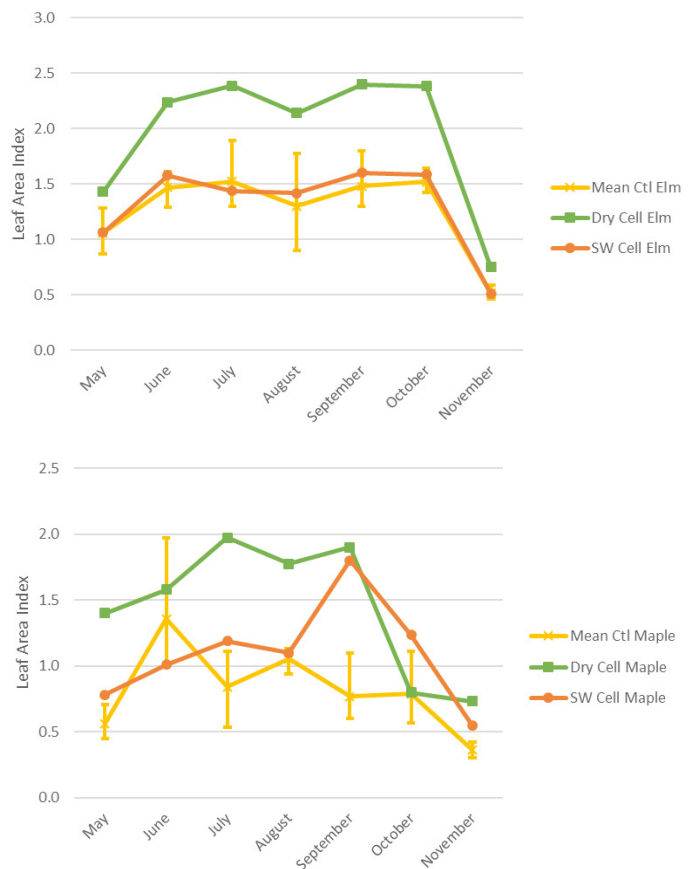
**Figure 7:** The leaf area indices of the stormwater cells, dry cells and control trees. Elm (left) and Maple (right). Error bars for the control trees represent the minimum and maximum observed values.

**The dry cell trees had the greatest leaf area index, followed by the stormwater cell and control trees.** Leaf area indices (LAI) for the stormwater cell and control tree Elms were similar, as were the Maples, although the stormwater cell Maples showed higher LAIs than the control in the months of September and October.

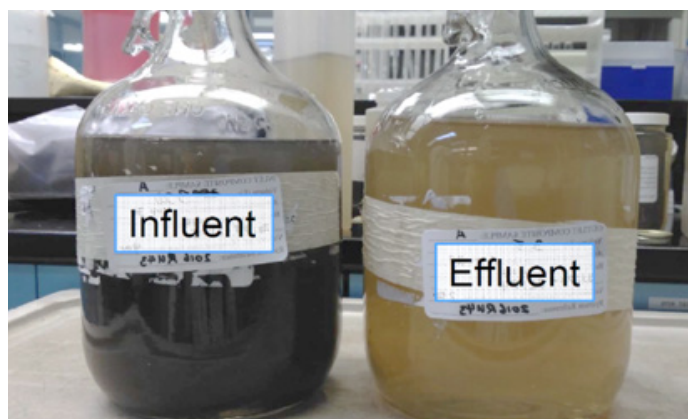
**Figure 8.** Distinct colour differences were observed at the inlet and outlet of the facility. Picture courtesy of Cheung and Anderton, 2017

**good overall stormwater runoff treatment (Table 1, Figure 8).** Effluent total suspended solids concentrations were consistently below 20 mg/L, and most contaminants showed positive removal except nitrate, which was likely augmented through leaching from the soil. Dissolved pollutants such as orthophosphate, chloride and nitrate are often not effectively removed by soil filtration (STEP, 2019).

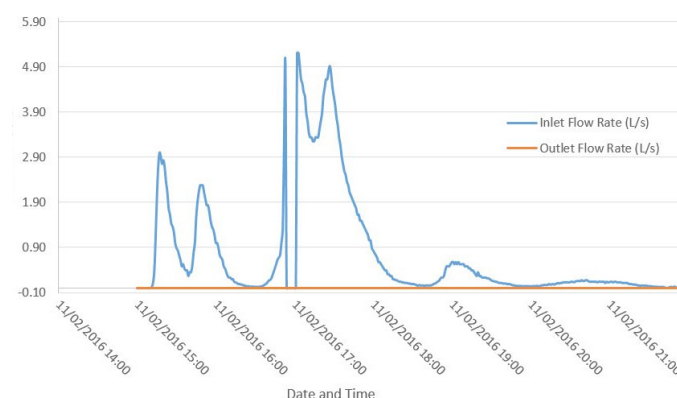
**Figure 9:** A 5.8 mm rain event on November 2nd, 2016 that generated no outflow. Source: Cheung and Anderton, 2017

**Flow and soil moisture measurements during summer storms also showed appreciable volume reductions with some rain events less than 6 mm producing no runoff (Figure 9).** Since the cells were lined to prevent infiltration, the observed volume reductions were attributed primarily to temporary soil storage and evapotranspiration. Some losses to infiltration may have also occurred through leaks in the liner.
